Prepared for:

Crown Agents Limited

1. Introduction

This solar site Physical Survey Report is in line with the Scope of Services defined in the Terms of Reference (TORs). While some of the Healthcare Centers are in the urban area, many of the Primary Healthcare Centers are located in the rural areas and are in deplorable states.

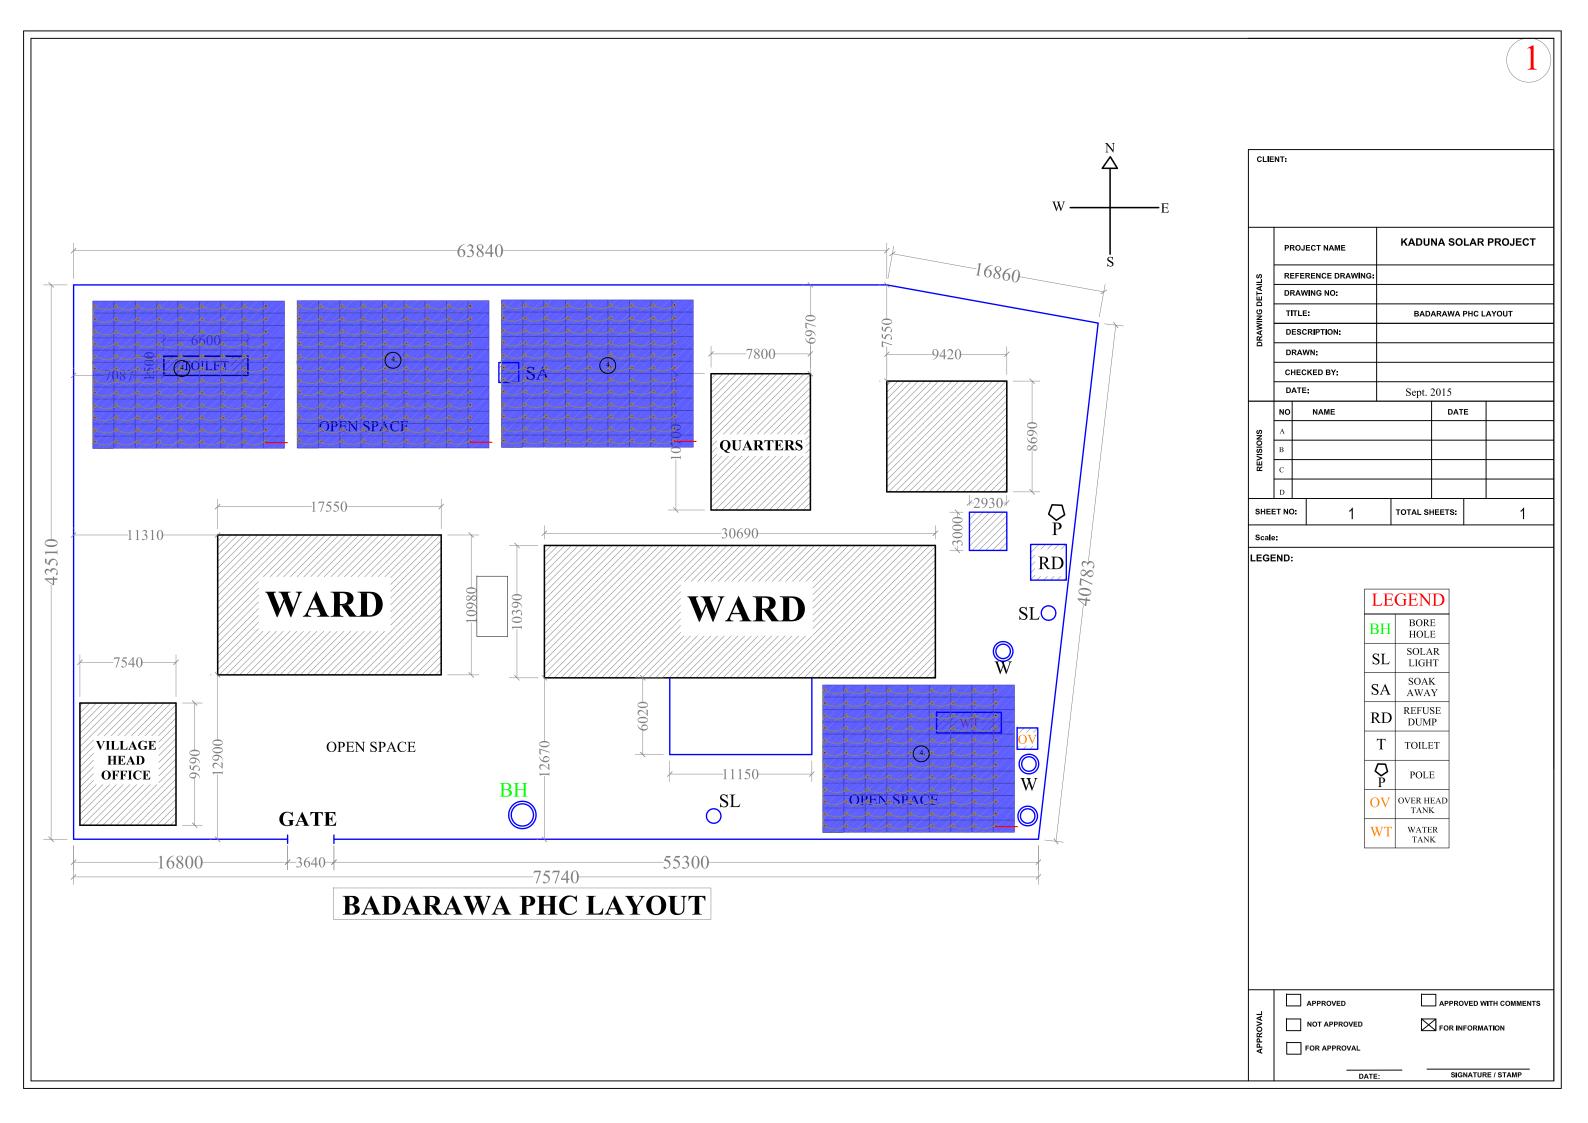
- 1. Available space for the installation of a proposed solar system is located at the front and back of the PHC building.
- 2. Access to the available space behind the main PHC building is obstructed by a soak away pit. This will cause access problems for heavy vehicles.

- 1. The soak away pit obstructing the available space must be reinforced.
- 2. The available space may be used for the installation of a solar system.

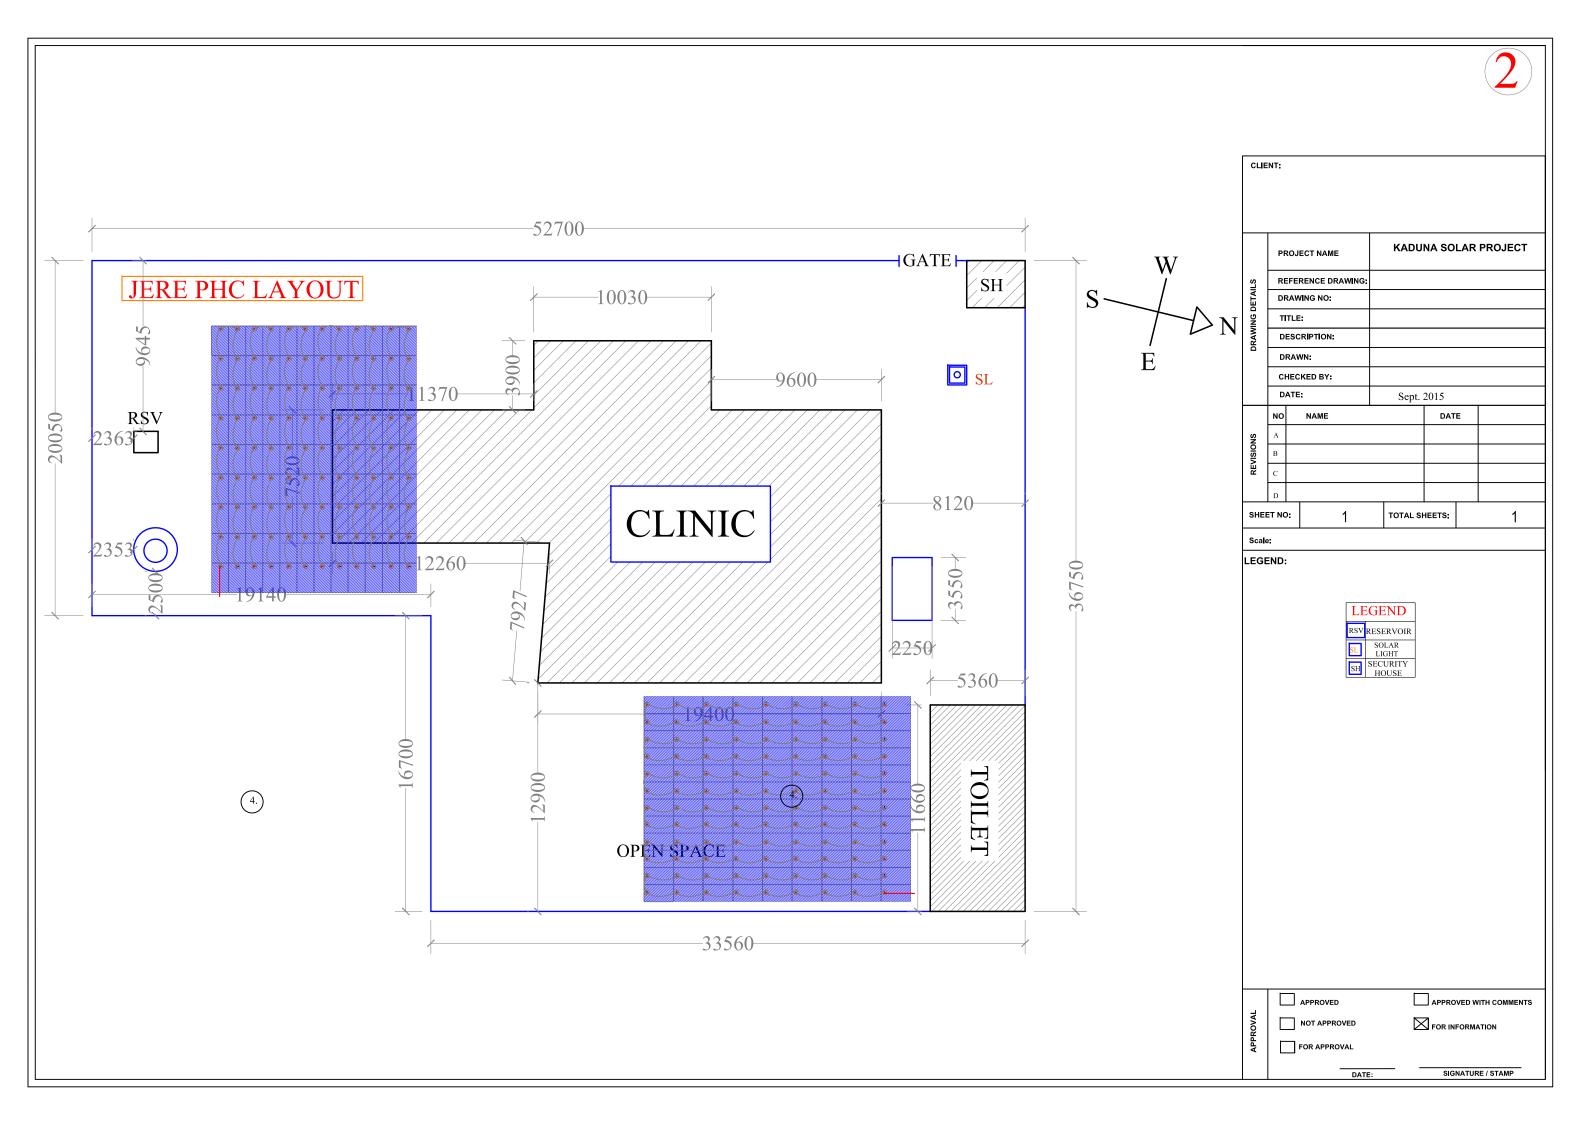
SUMMARY FOR JERE PHC

- 1. Due to weak signal reception at the PHC, there will be telecommunication issues.
- 2. Overhead lines at the entrance of the PHC will cause problems for heavy vehicles entering the PHC.

- 1. Alternative telecommunication services must be considered for system remote monitoring.
- 2. Overhead powerlines must be relocated or raised higher for vehicle access.

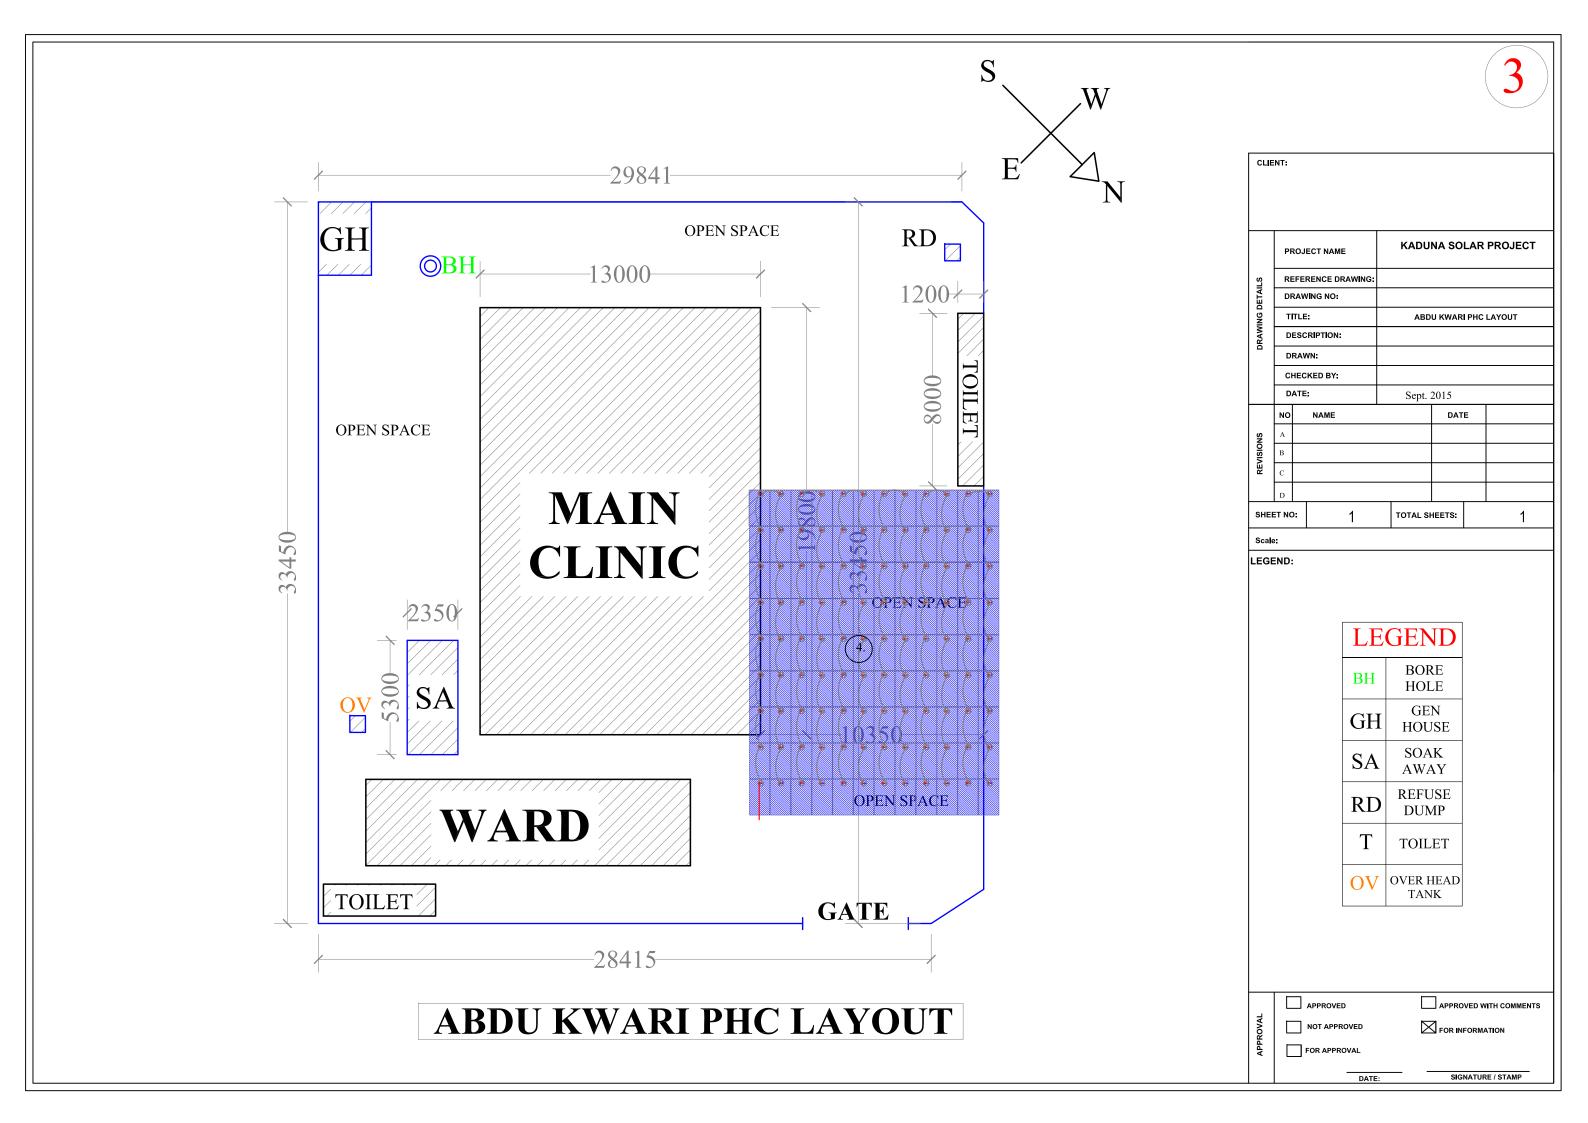
SUMMARY FOR ABDU KWARI PHC

- 1. Weak signal reception at this PHC will cause telecommunication problems of the available service providers.
- 2. Overhead powerlines hanging at the entrance into the PHC may cause problems for heavy vehicles entering the PHC.

- 1. Alternative telecommunication services must be considered for system remote monitoring.
- 2. Overhead lines must be relocated or raised higher for ease of vehicle access.

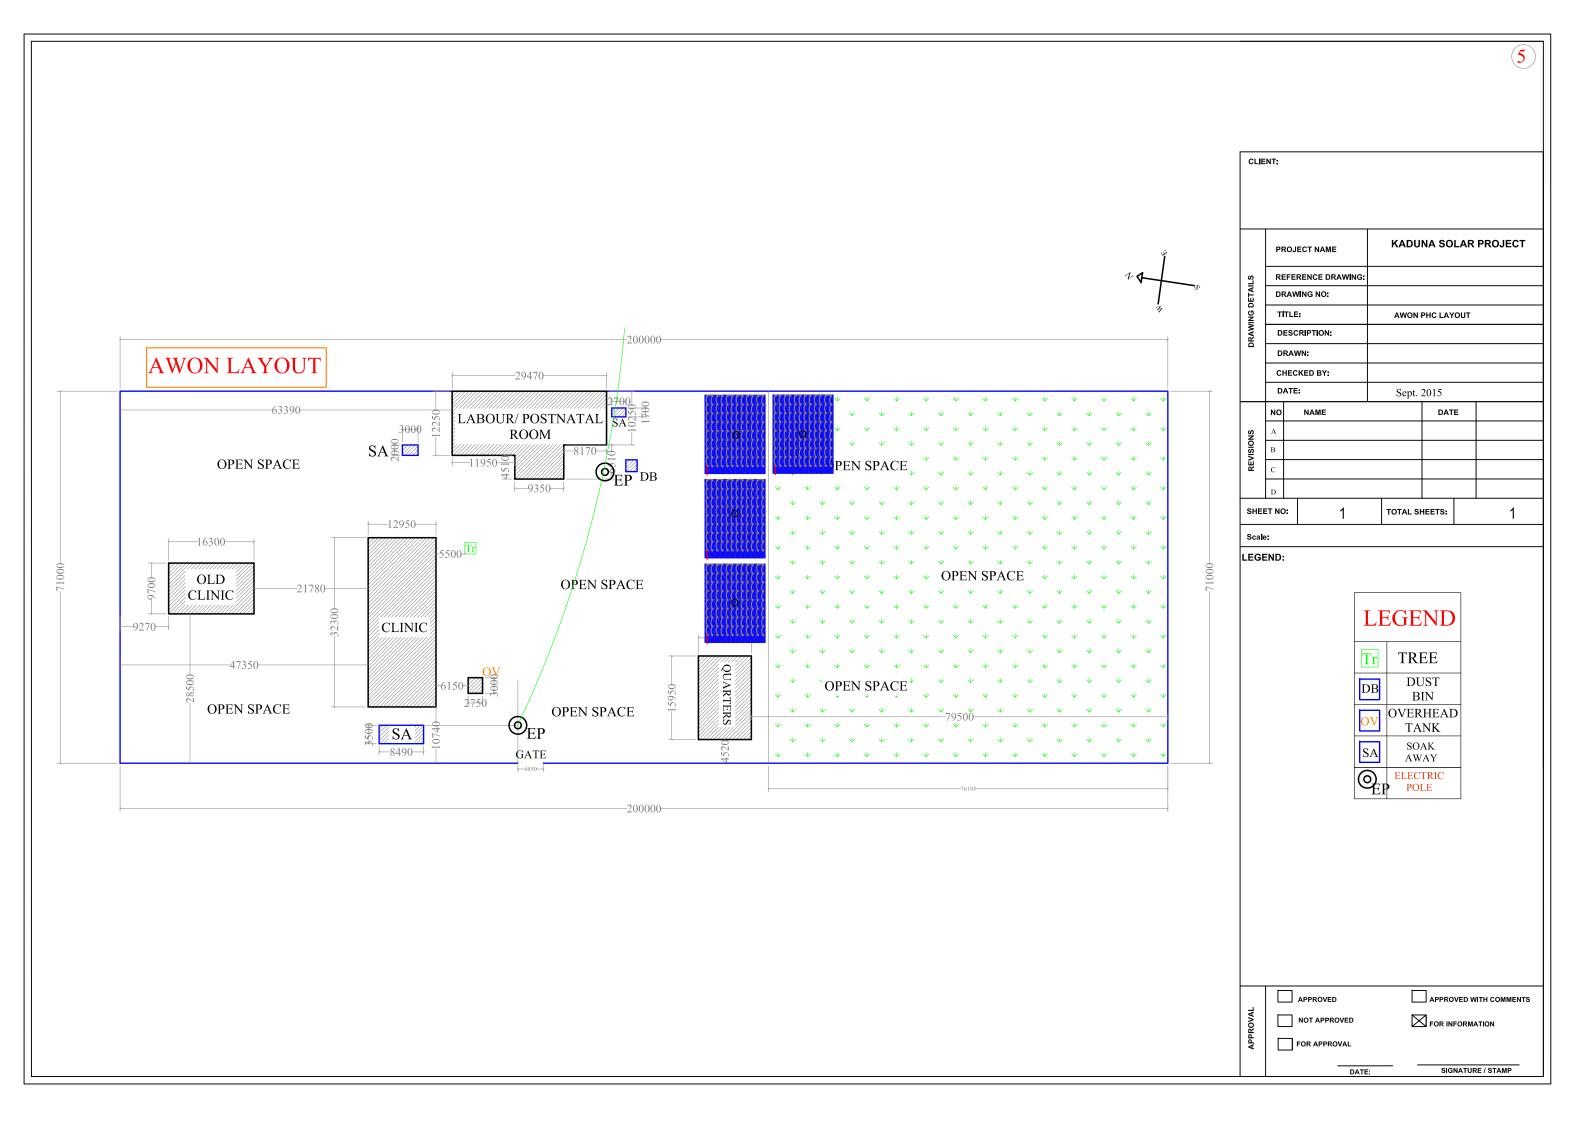
SUMMARY FOR AWON PHC

- 1. Overhead powerline crossing the PHC must be relocated (indicated as EP on layout)
- 2. Available space is used for farming.

- 1. Overhead powerlines must be relocated.
- 2. Available space must be cleared of vegetation.

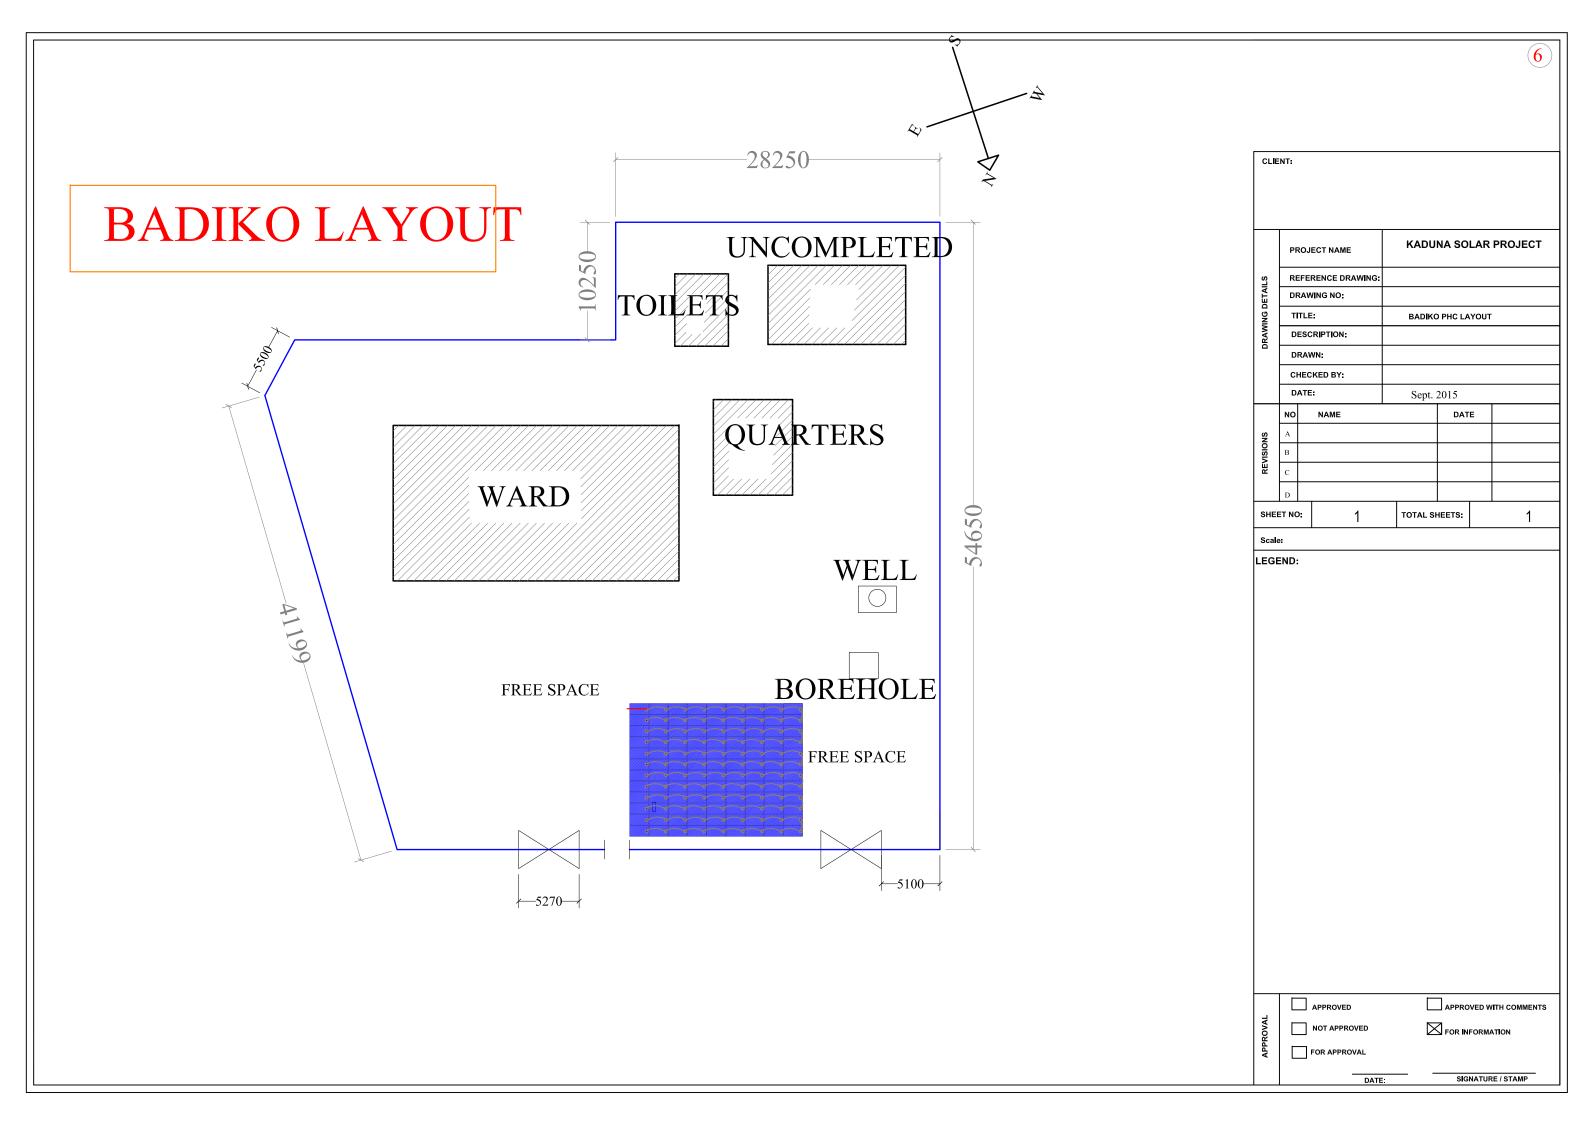
SUMMARY FOR BADIKO PHC

1. Access road to PHC is rough terrain.

- 1. Access road must be repaired.
- 2. Carport design proposed in the front of the PHC.

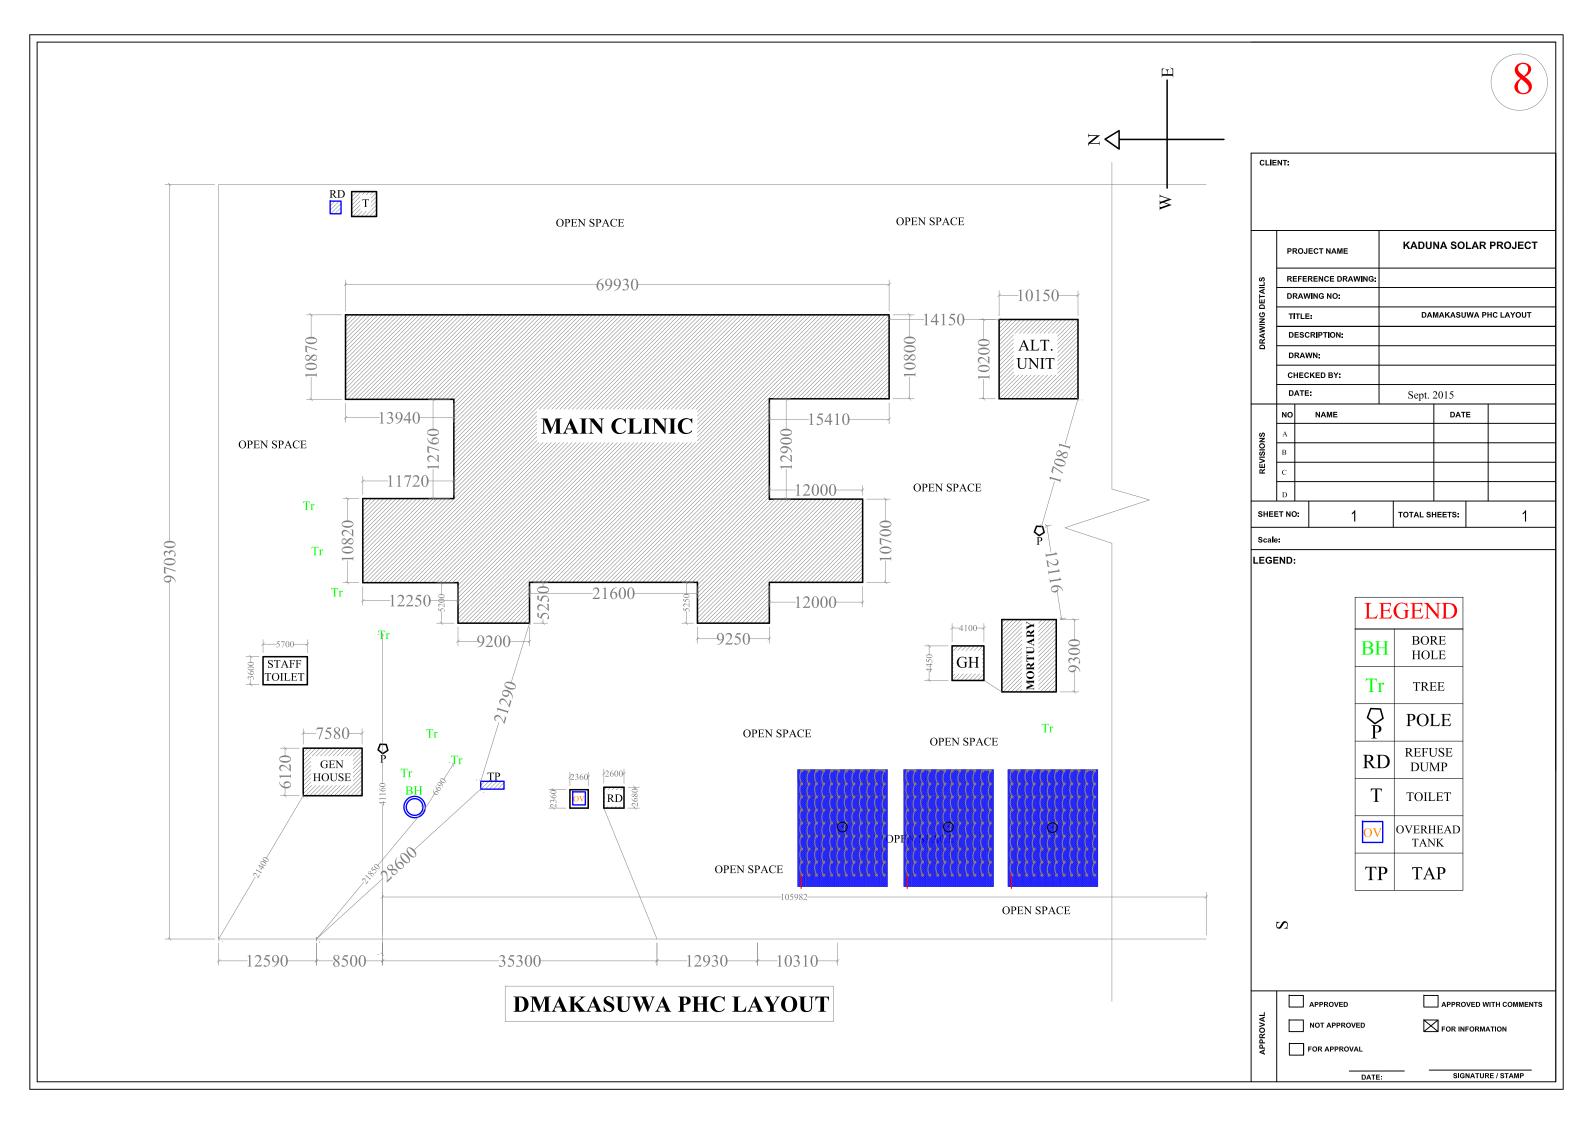
SUMMARY FOR DAMAKASUWA PHC

1. Boundary wall in the PHC is not complete with front of wall missing.

1. Boundary wall must be completed to secure installation and PHC.

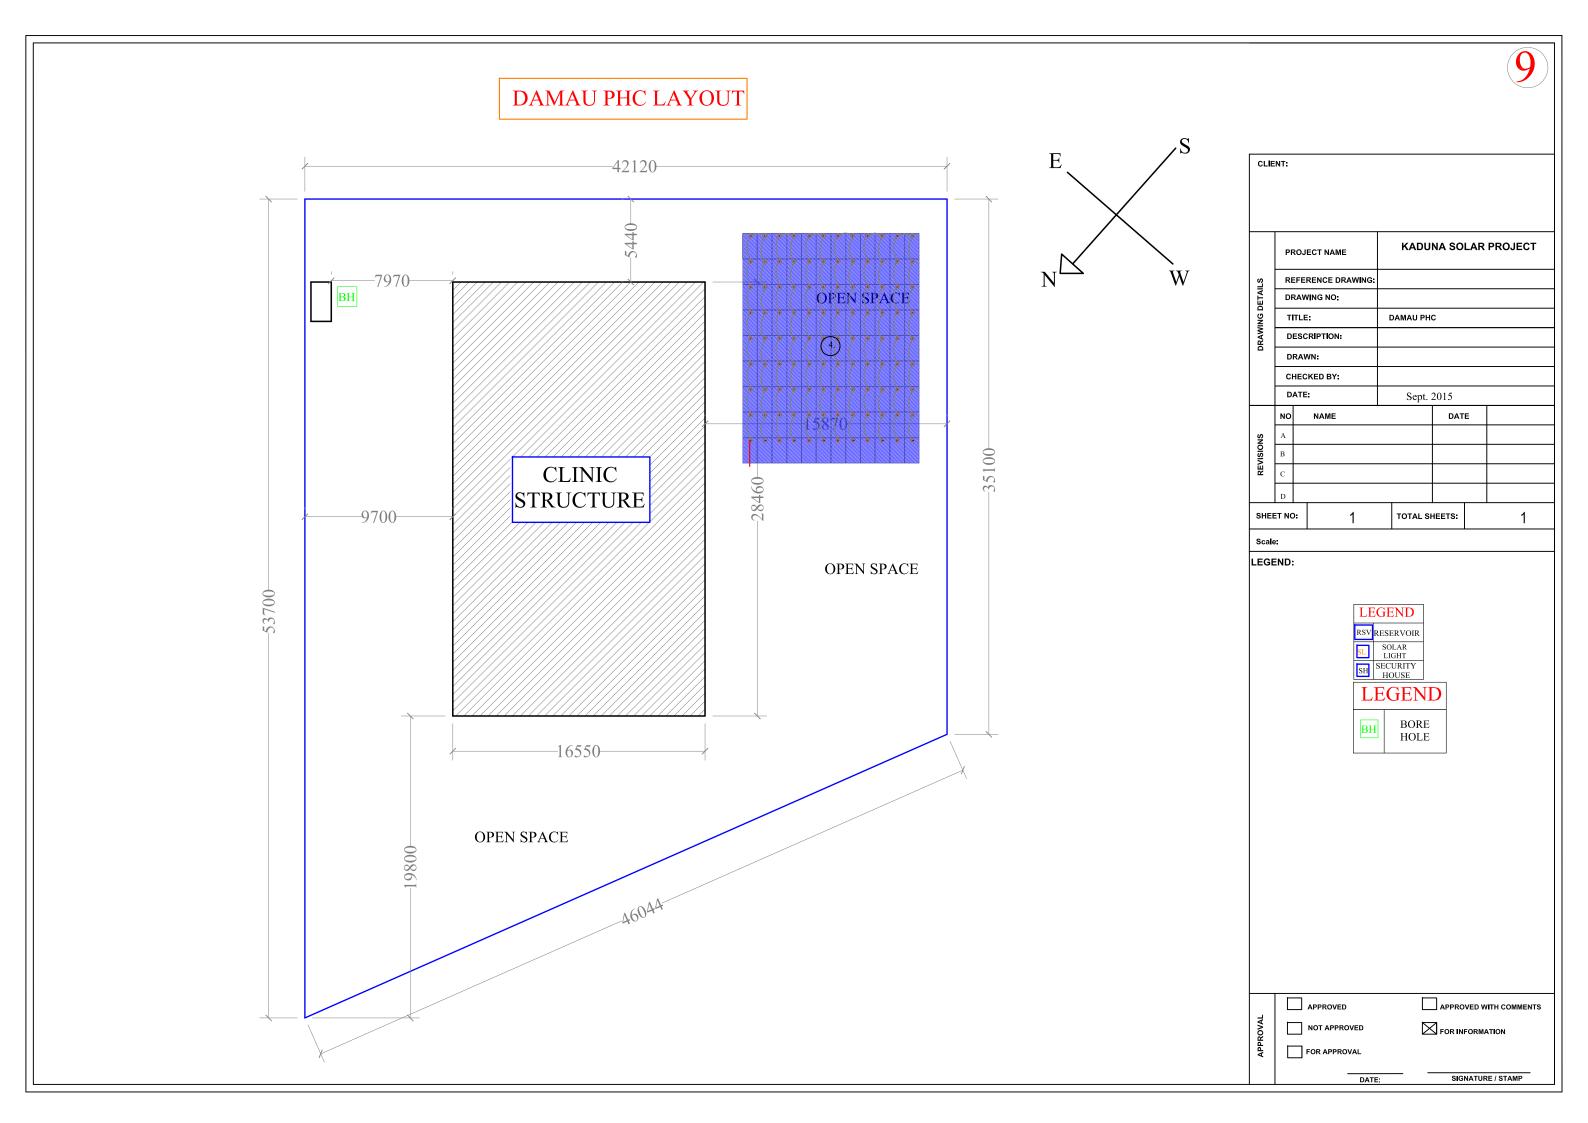
SUMMARY FOR DAMAU PHC

1. Boundary wall in the PHC available but is missing an entrance gate.

1. Entrance gate must be constructed to secure installation and PHC.

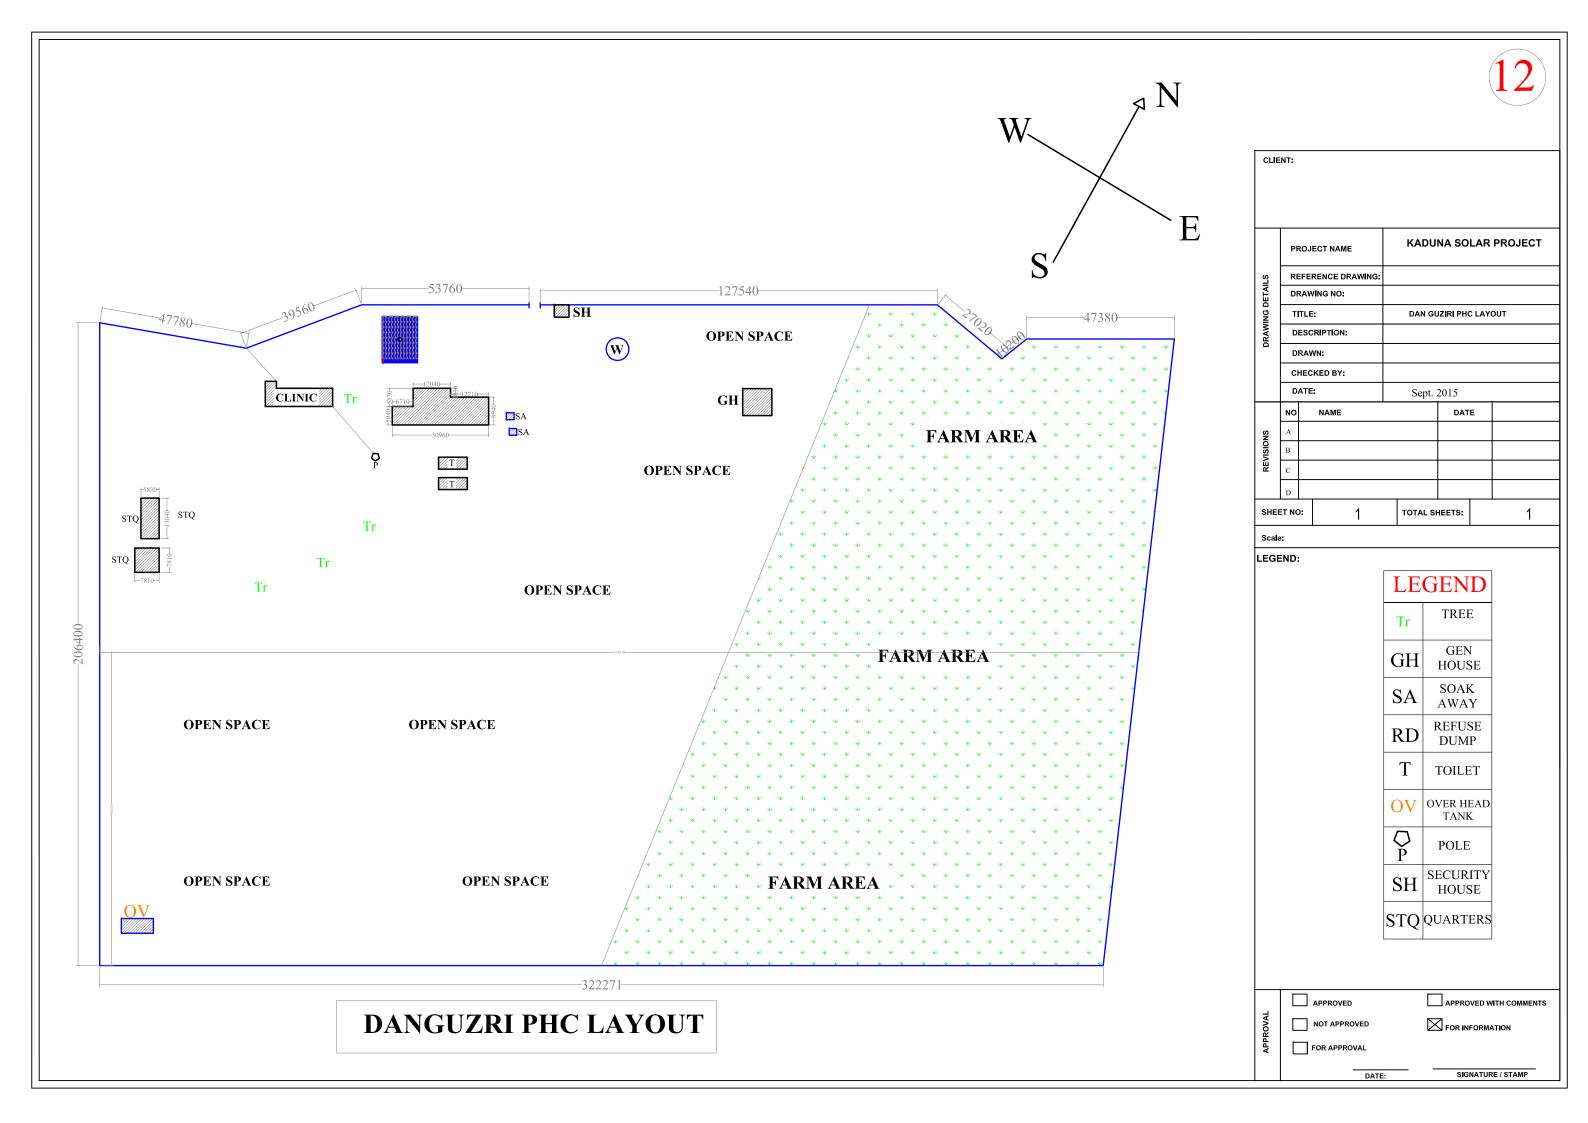
SUMMARY FOR DAN GUZURI PHC

- 1. Boundary wall is not complete.
- 2. Available space is used for farming.
- 3. Available space has trees.

- 1. Boundary Wall must be completed for security.
- 2. Available space used for farming must be cleared of vegetation for a solar system to be installed.
- 3. Trees will cause obstruction and shading and must be cut down.

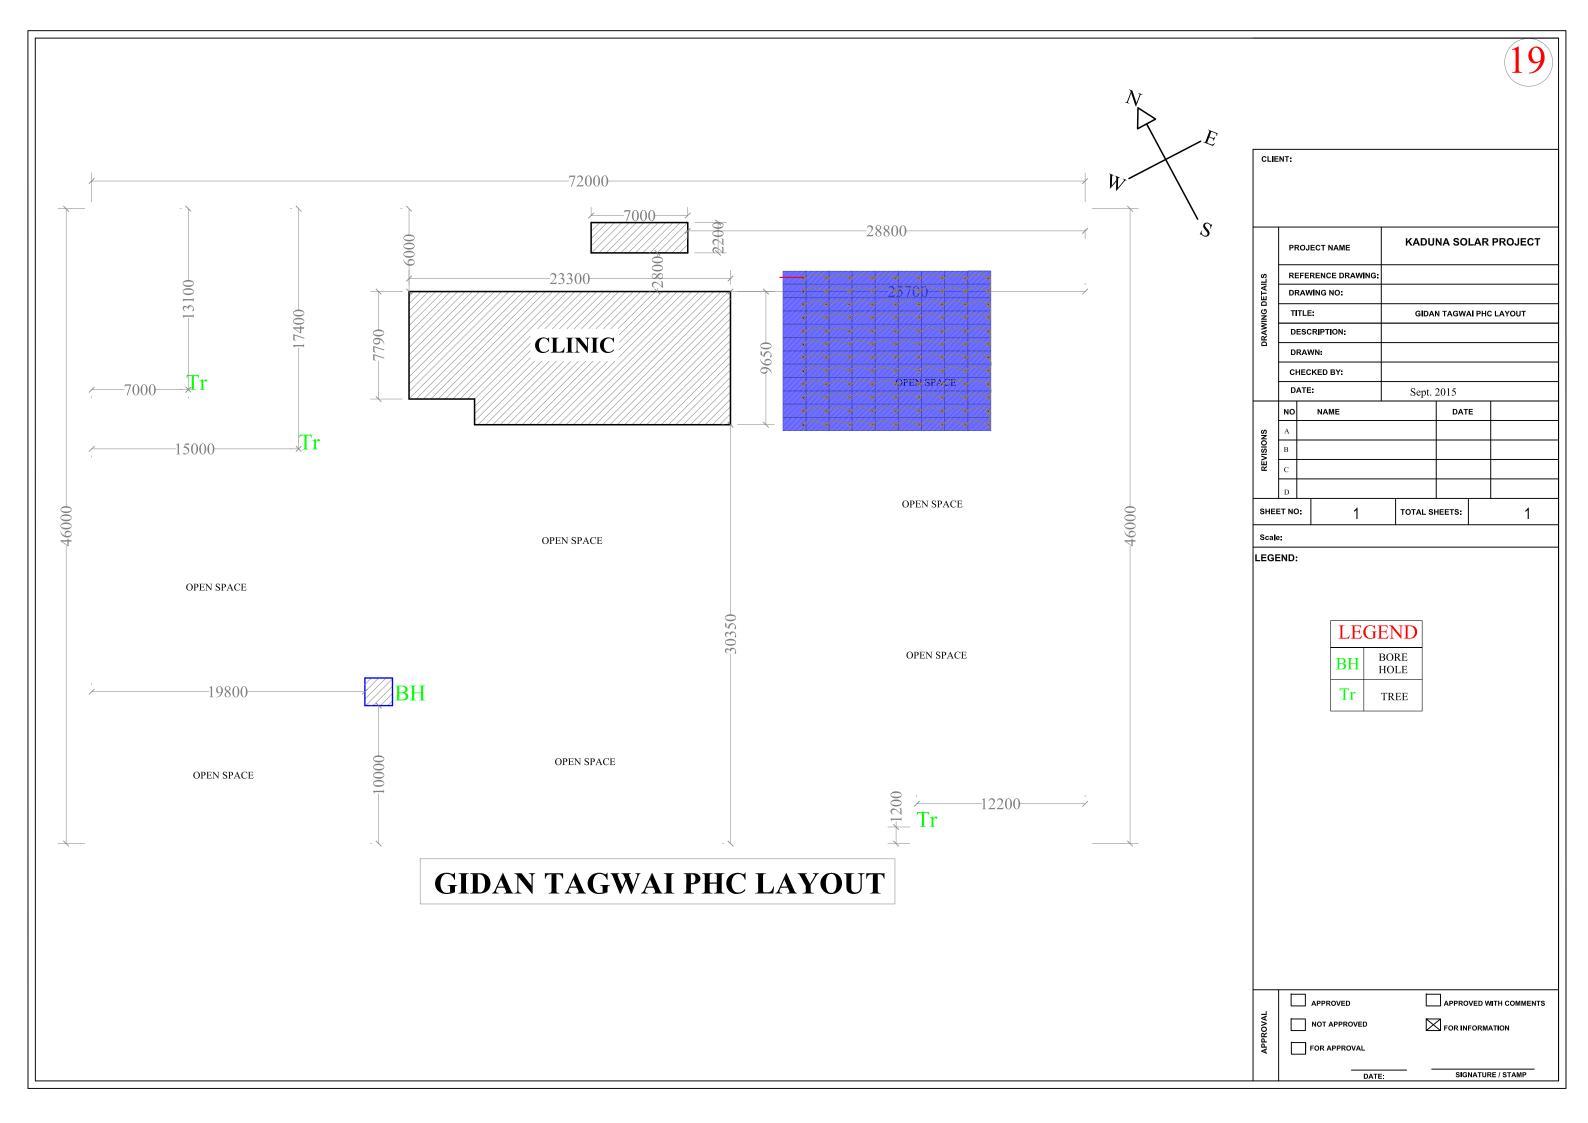
SUMMARY FOR GIDAN TAGWAI PHC

- 1. This PHC has no boundary wall.
- 2. Overhead lines will cause obstruction when accessing the site.

- 1. Boundary wall must be completed to secure installations and the PHC.
- 2. Overhead lines must be raised higher or relocated.

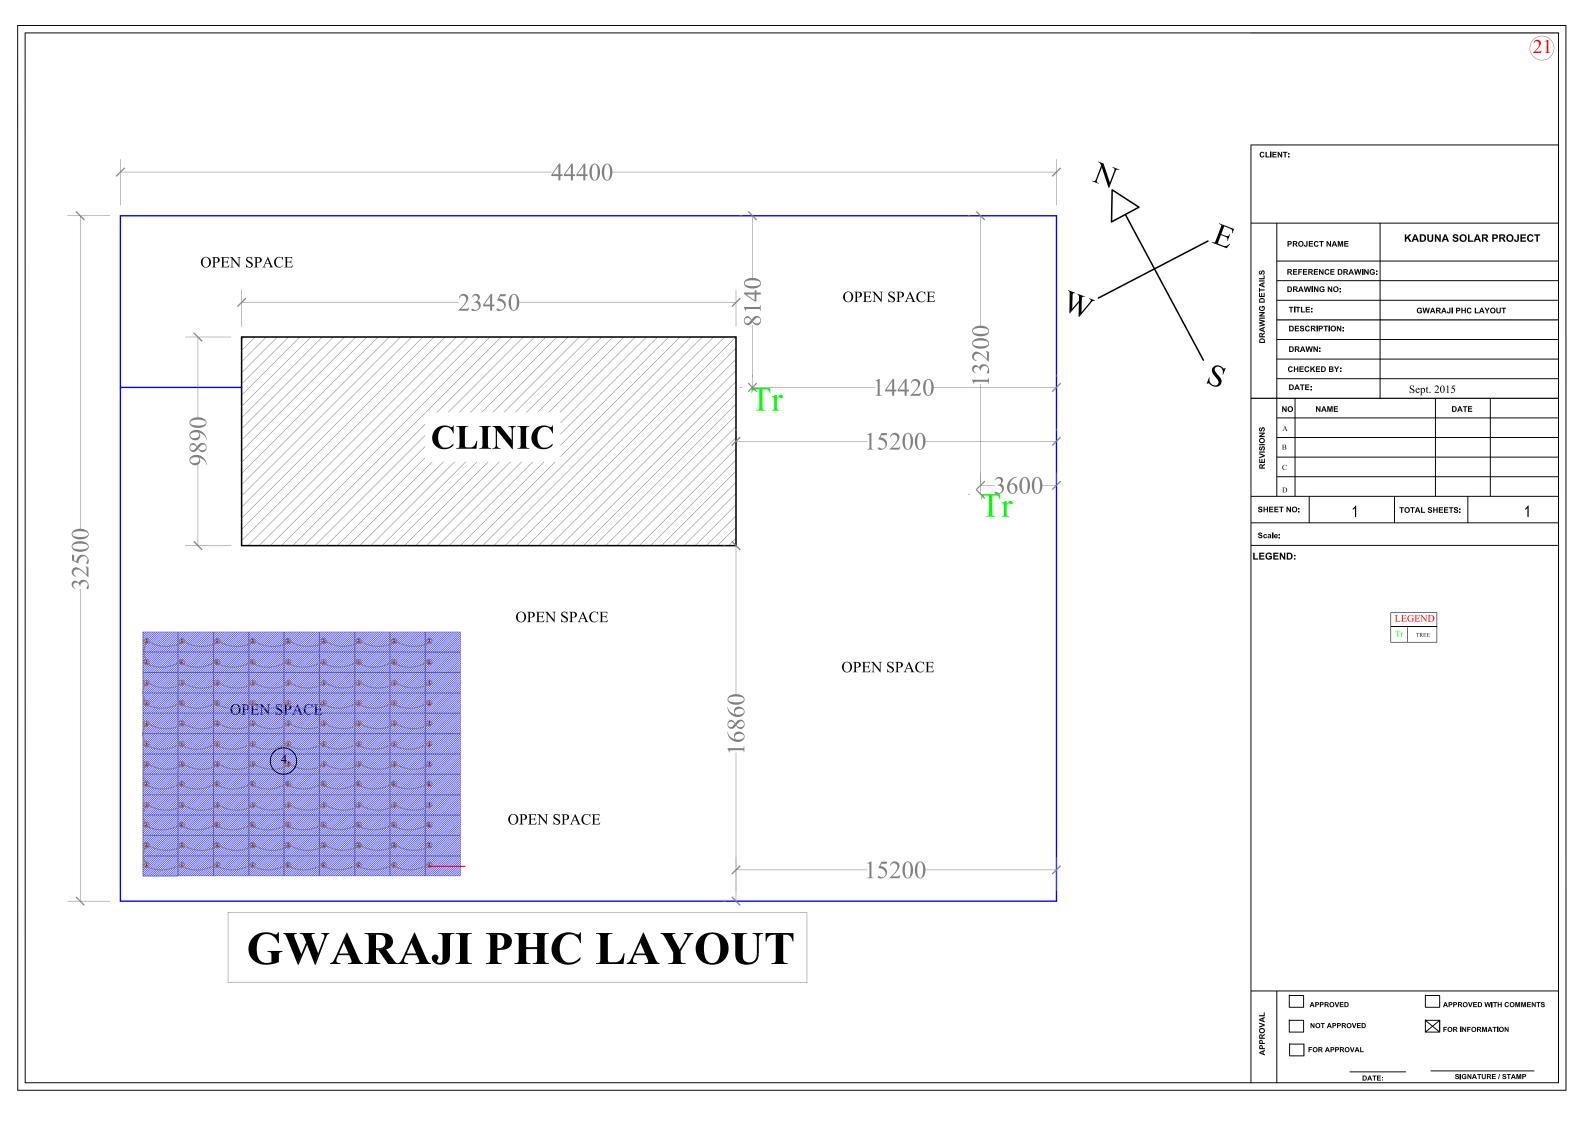
SUMMARY FOR GWARAJI PHC

- 1. This PHC has no boundary wall.
- 2. Available space is used for farming.

- 1. Boundary wall must be completed to secure installations and the PHC.
- 2. Available space must be cleared of vegetation for system installation.

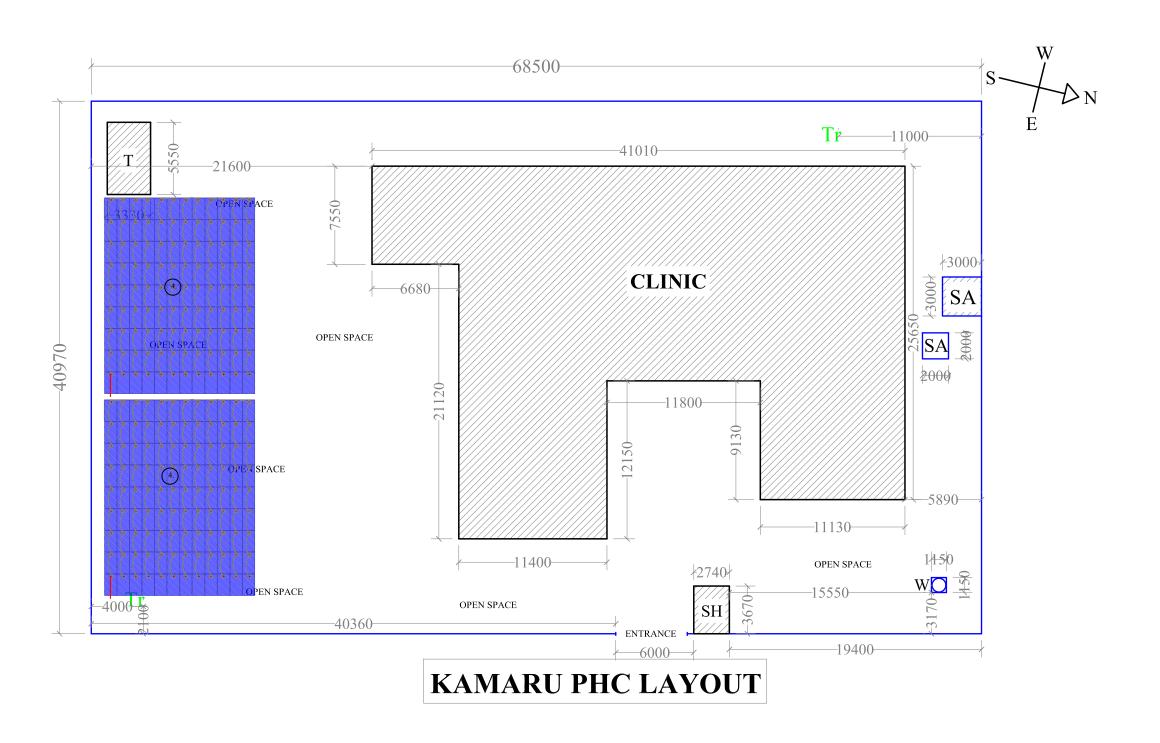
SUMMARY FOR KAMURU IKULU PHC

- 1. Entrance gate is narrow.
- 2. Overhead powerlines will cause obstruction for heavy vehicles when entering the PHC.

- 1. Entrance gate must be expanded.
- 2. Overhead powerlines must be relocated or raised higher.

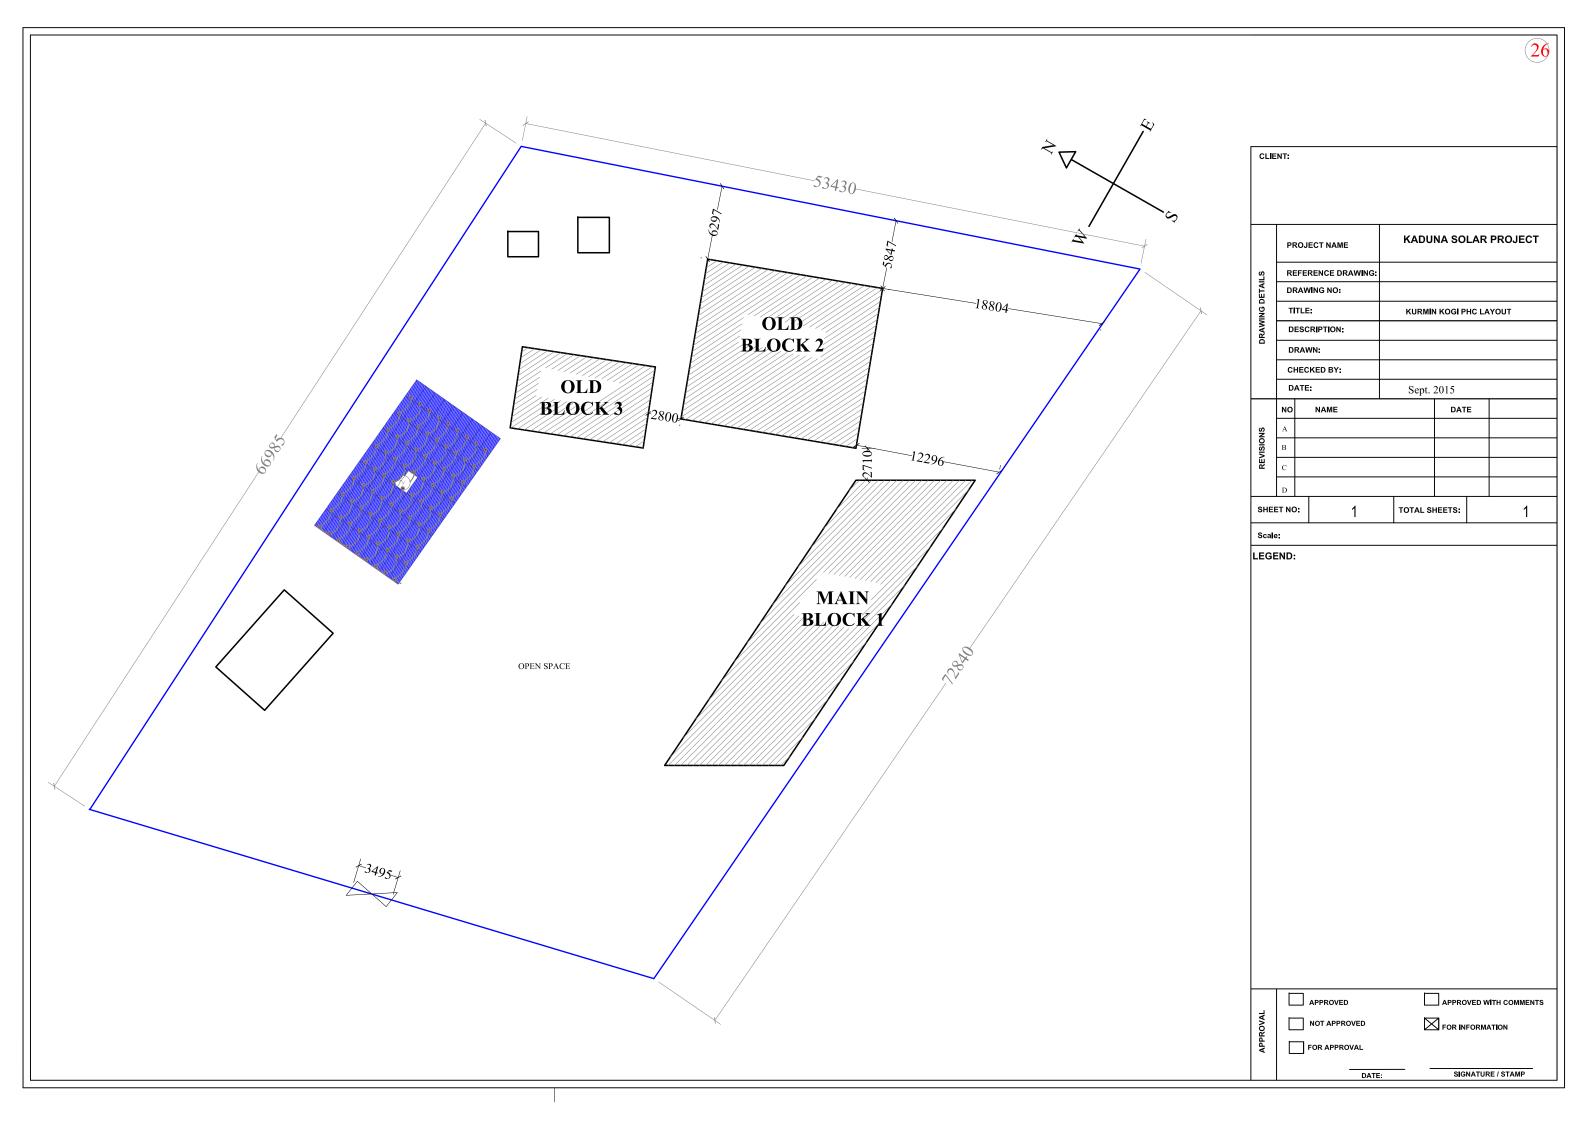
SUMMARY FOR KURMIN KOGI PHC

- 1. Overhead lines will cause obstruction for vehicles accessing the PHC.
- 2. High rise buildings may cause shading in available space.
- 3. The ETISALAT telecommunication has poor reception.

- 1. Overhead powerlines will need to be relocated or raised higher for heavy vehicle passage to the
- 2. Alternative to ETISALAT telecommunication network must be sourced.
