Prepared for:

Crown Agents Limited

1. Introduction

This solar site Physical Survey Report is in line with the Scope of Services defined in the Terms of Reference (TORs). While some of the Healthcare Centers are in the urban area, many of the Primary Healthcare Centers are located in the rural areas and are in deplorable states.

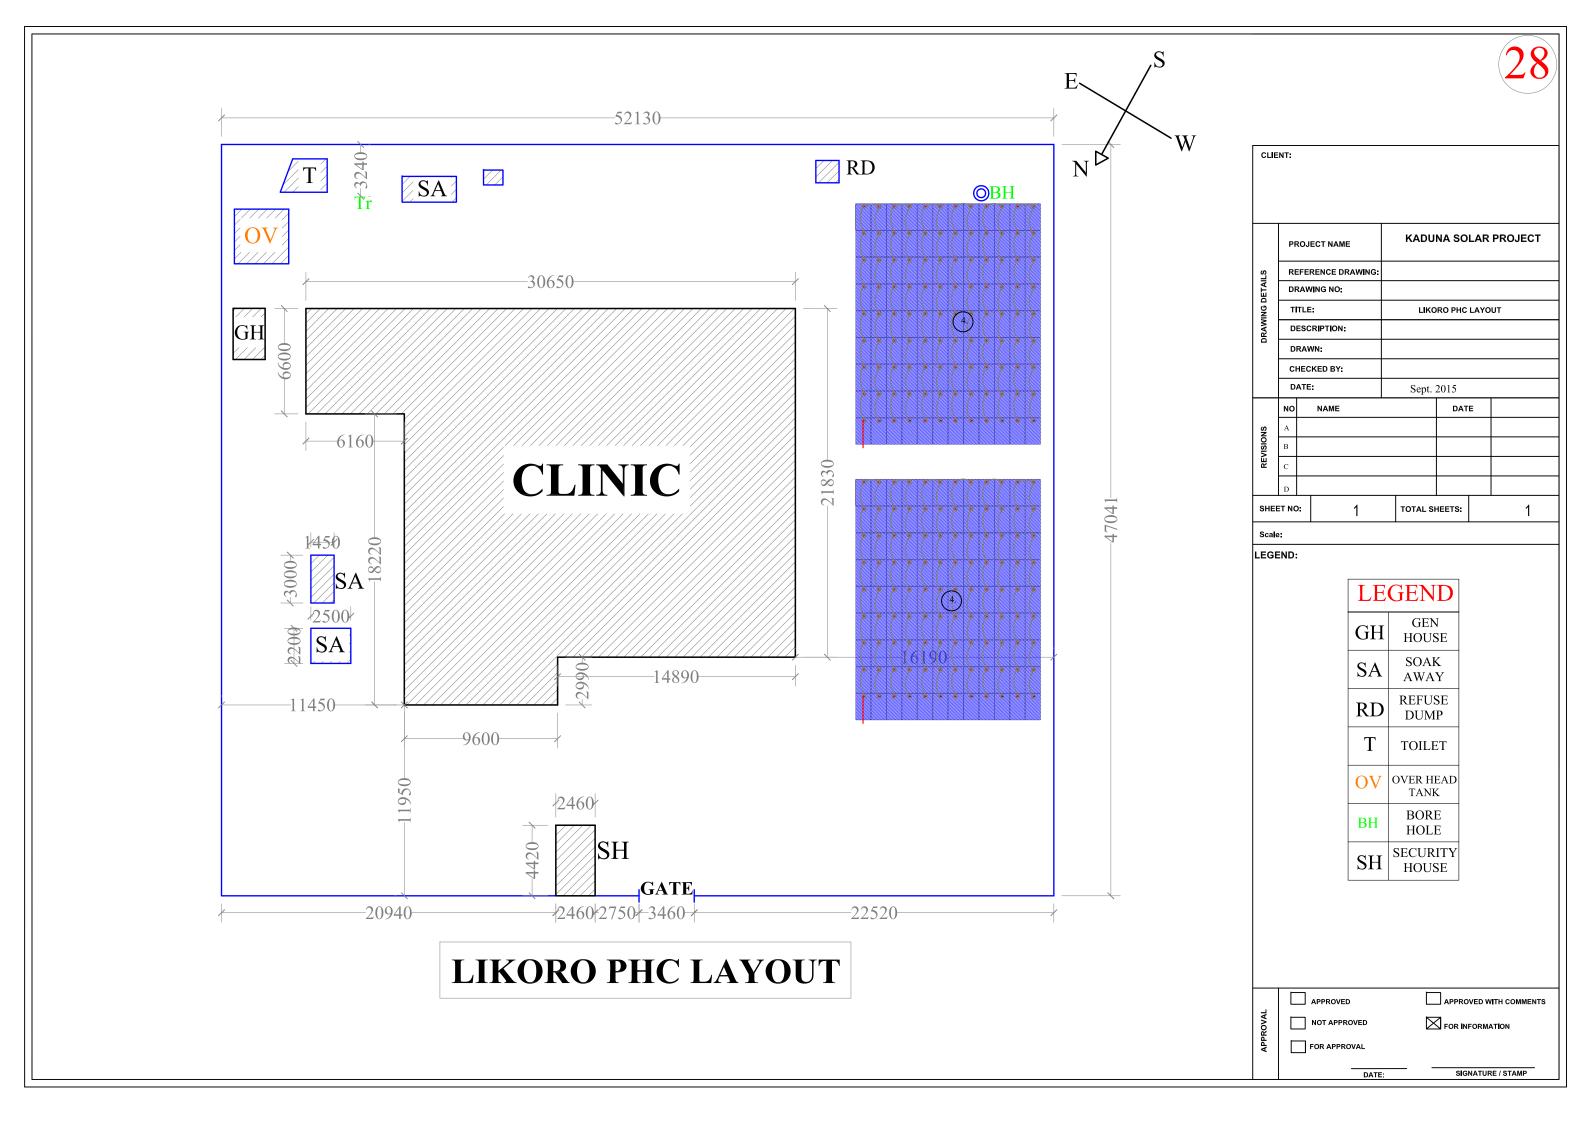
SUMMARY FOR LIKORO PHC

- 1. PHC entrance gate is narrow.
- 2. Neighbouring boundary wall will cause obstructions for vehicles to the site.

- 1. PHC entrance gate must be expanded.
- 2. Neighbouring boundary wall must be broken down and reconstructed to allow trucks to move into the PHC.
