Prepared for:

Crown Agents Limited

1. Introduction

This solar site Physical Survey Report is in line with the Scope of Services defined in the Terms of Reference (TORs). While some of the Healthcare Centers are in the urban area, many of the Primary Healthcare Centers are located in the rural areas and are in deplorable states.

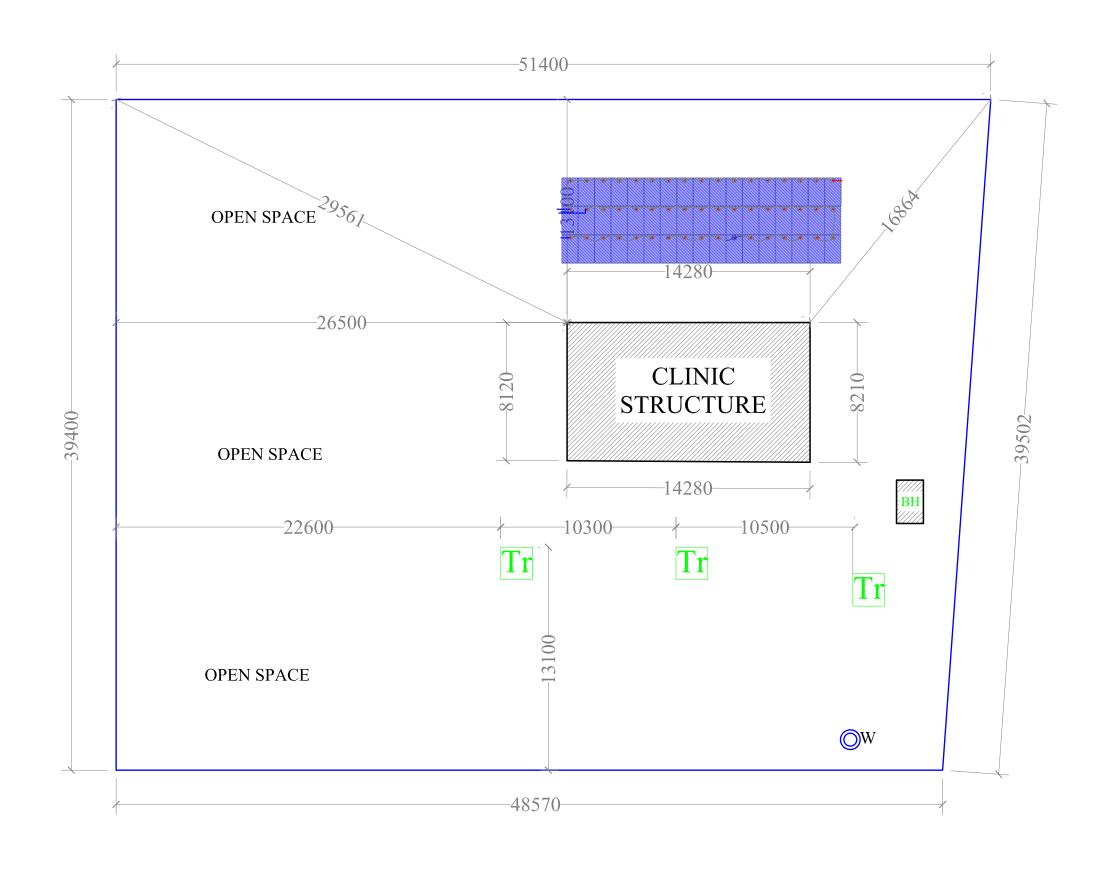
MAH PHC LAYOUT

1. Available space needs further observation.
